Operation of the Lake Erie - Niagara River Ice Boom

A report to the
International Niagara Board of Control
by the
International Niagara Working Committee

September 2003

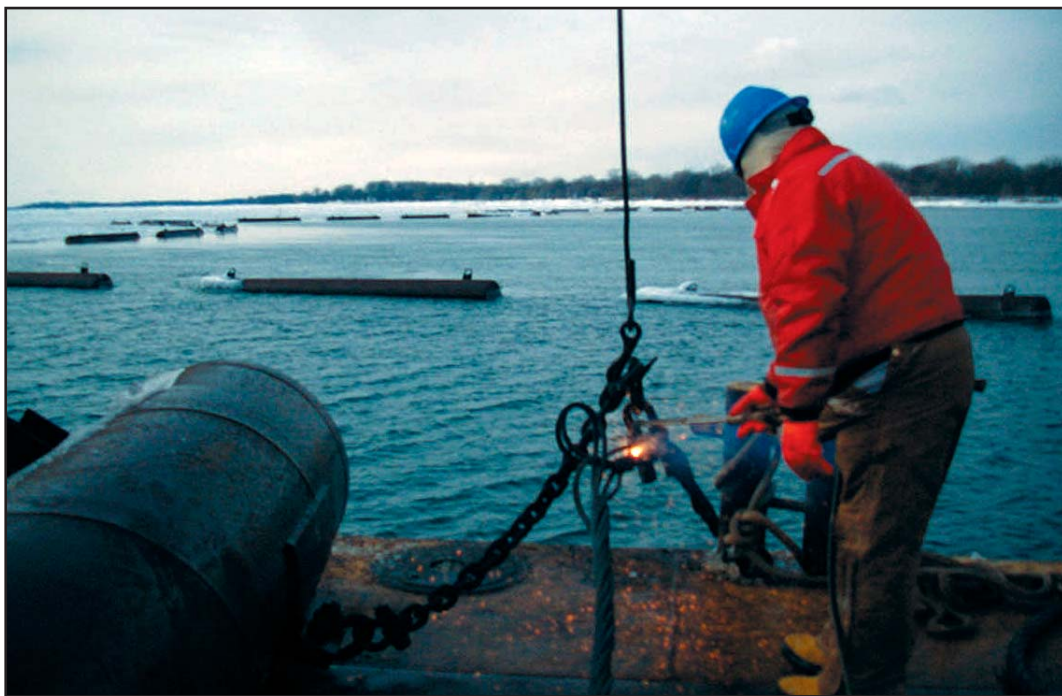
*Cover:
Repair work underway following
4 February Storm event (NYPA Photo)*

Due to the severe conditions encountered during the 4 February 2003 storm and the resulting damage to the Ice Boom and its components, the maintenance required this summer was much more than normal. Thirteen span cables and numerous hardware components (clamps, shackles, etc.) needed replacement, and several floatation barrels were repaired. A Power Entities' study is also underway to investigate the factors involved in the failure of twelve spans during the early February event.

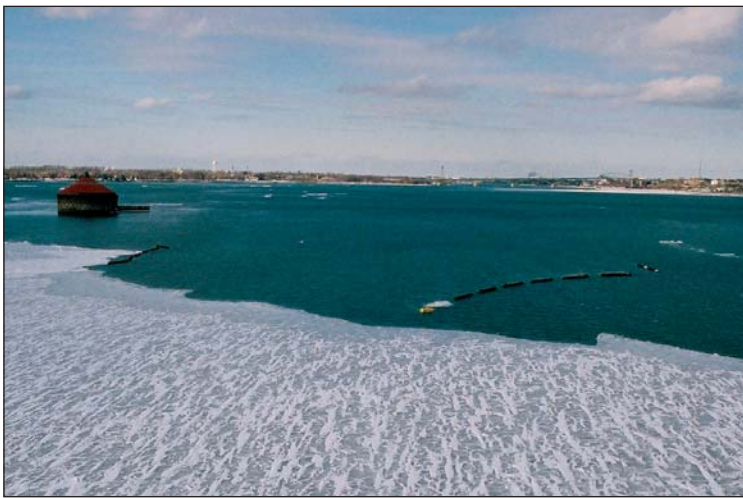
A major breach of the ice boom occurred during a storm event on 4 February when 12 of the boom's 22 spans were opened. Closure of the boom was completed on 26 February, 2003.

Weather conditions after the event delayed repairs. The NYPA crew had to retrieve 24 pontoons and several floatation barrels from various locations along the upper Niagara River as they had been detached during the event. Closing of spans started on 7 February. Repairs were made to damaged anchor cables, and broken or stressed clamps, while equipment such as chain links, etc. were replaced. Boom closure was completed on 26 February. There was no ice jamming and no instances of flooding or reports of shoreline property damage.

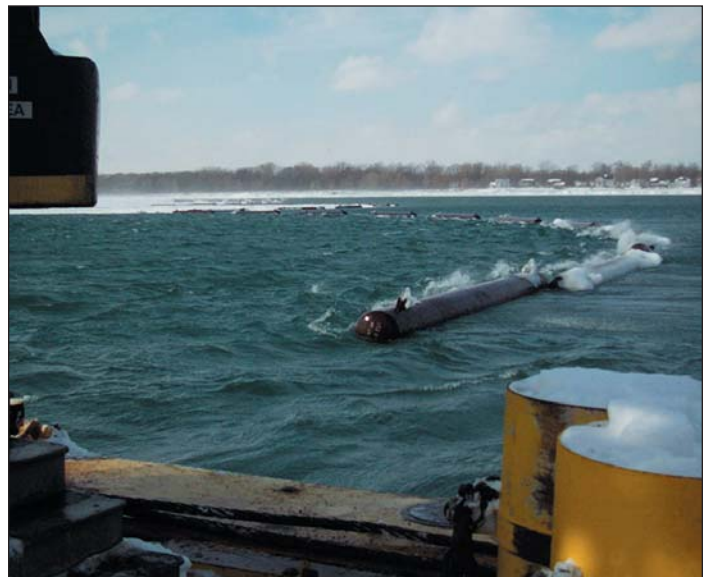
Air temperatures in the 5 days prior to the storm were above freezing and contributed to the ice field behind the boom becoming unstable. Boom components were bonded into the ice and unable

to submerge when exposed to pressure from the ice field. The rising lake level broke the ice arch upstream of the boom. Large ice floes detached from the central portion of the shore bound ice field and moved downstream. The force exerted by the moving ice field resulted in 12 of the ice boom's 22 spans being forced open. Some of the open spans also received extensive damage, including stretched or broken cables, detached pontoons and damaged hardware. One anchor cable was also broken and several floatation barrels were damaged.

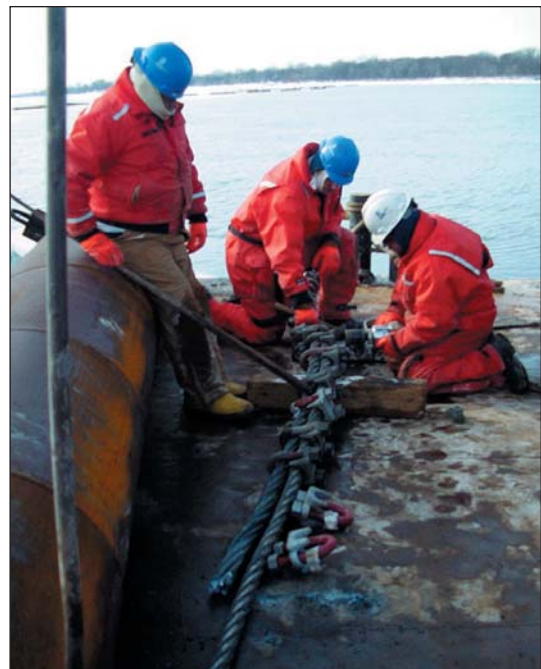
When in position, the 2700 metre (8,800 foot) ice boom spans the outlet of Lake Erie and is located approximately 300 metres (1,000 feet) southwest of the water intake crib for the city of Buffalo. The boom is made up of 22 spans. Starting with the 1997-1998 season, the boom spans consisted of a series of 11 floating steel pontoons. Spans are anchored to the lake bed at 122 metre (400 foot) intervals by 6.4 centimetre (2.5 inch) diameter steel cables. Each pontoon is 76 centimetres (30 inches) in diameter and 9 metres (30 feet) long. Beginning in 1998-99, spans A through J contained 10 instead of 11 pontoons to reduce the potential for collisions during open water conditions. A map of eastern Lake Erie showing the location of the ice boom is included as Figure 5. Figure 6 is a map of the upper Niagara River. Figure 7 illustrates structural details and a plan view of the ice boom.
